U.S. DEPT. OF THE INTERIOR OFFICE OF SURFACE MINING

Mine Site Evaluation State Program

Mine Name: Wildcat Loadout
Operator: America West Resources
Permittee: Intermountain Power Agency

America West Resources Wildcat Loadout, UT-007-033 OSM Complete Inspection

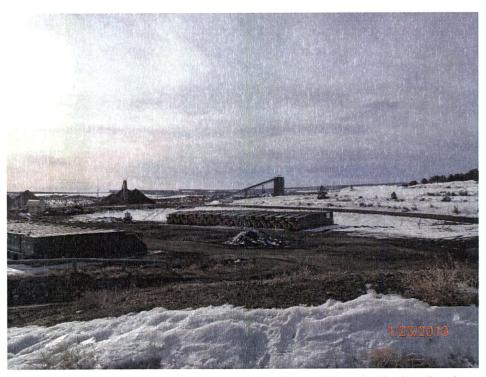
Numerous frack tanks containing oil are located with the permit boundary even though the storage of these tanks is not in the approved permit (Figure 5). The operator stated that they belong to and are being maintained by the rail road. The operator and DOGM need to either have these tanks removed, or implement a permit revision allowing the storage of these tanks within the permitted area.

Figure 5 - Frack tanks containing oil, being stored with in the permit boundary by the rail road

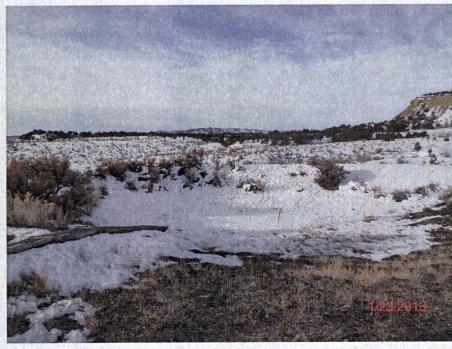
Photo ID: 10103

Sediment pond F

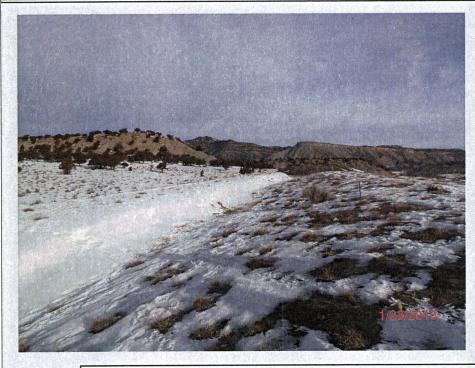
Photo ID: 10104

Topsoil piles A, B and F, and subsoil pile E were inspected and all storage piles were marked with visible and appropriate signage. The piles show no signs of instability and the vegetative cover is adequate based on the climate and is in line with surrounding undisturbed areas.

Topsoil pile B (right) and Subsoil pile E (left)
